HF 酸处理对石英玻璃 355 nm 激光损伤影响研究

迟海军¹,高 勋¹,赵东峰²,林景全¹
(1. 长春理工大学理学院,吉林长春 130022;
2. 上海光学精密机械研究所高功率激光物理联合实验室,上海 201800)

Study on influence of HF acid treatment on 355 nm laser damage of quartz glass

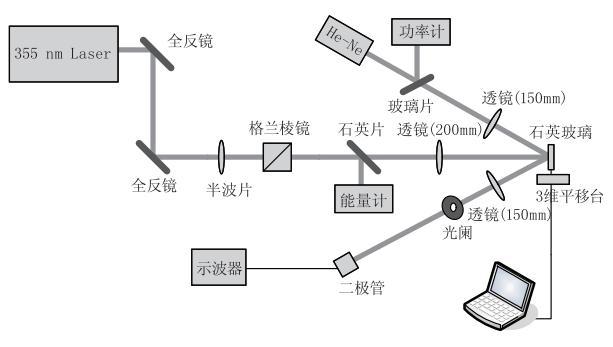
参考国际标准 ISO - 11254 和国家标准 GB/ T-16601,355 nm 脉冲激光诱导石英玻璃的光学损 伤阈值测试装置如图1 所示。

Nd:YAG激光器(德国 Innolas 400) 三倍频输 出波长为355 nm,脉宽8 ns,光斑直径5 mm 的激光 光束,355 nm 二分之一波片和激光格兰棱镜组成能 量衰减系统用来连续改变激光脉冲能量,在实验光路 上放置一石英玻璃分束片,分出的激光能量用激光能 量计(探头:FieldMaxLL - TOP,型号:J-25MB-LE) 进行测量,计算给出聚焦到石英玻璃的激光脉冲能 量,经平凸石英透镜(f=200 mm)聚焦到石英玻璃 表面上,石英玻璃固定在三维平移台,在石英玻璃表 面位置的激光光束直径为108 μm。He-Ne激光经 透镜(f=150 mm)聚焦在石英玻璃355 nm 激光光 斑位置,利用功率计实时测量玻璃片分出的 He-Ne 激光功率,石英玻璃表面反射的 He-Ne 激光经过 透镜(f=150 mm)聚焦在光电二极管探测器表面, 示波器对反射的 He-Ne 激光功率值进行测量,比 较 355 nm 激光脉冲辐照石英玻璃前后的示波器数 值的变化,从而初步判断石英玻璃是否损伤。石英 玻璃的损伤形貌由金相显微镜(OLYMPUS,型号: DP72)对进行测量。实验样品石英玻璃(江苏海安 恒星光学元件厂生产,型号:JGS2)尺寸为 30 mm × 30 mm × 6 mm,双面抛光。

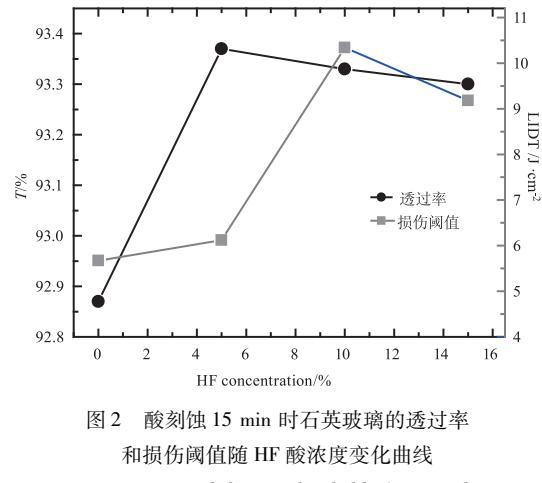
实验过程中 355 nm 激光对石英玻璃辐照为间 距4 mm 的6 ×6 点阵。采用国际 ISO - 11254 中 1 - on - 1方法,实验测得 HF 酸未处理的石英玻璃 100% 损伤阈值(laser induced damage threshold, LIDT)为5.67 J/cm²。为了提高石英玻璃 355 nm 激光损伤阈值,利用 HF 酸处理石英玻璃表面,需要 考虑 HF 酸浓度以及酸刻蚀时间,HF 浓度太高容易 导致酸腐蚀掉石英玻璃表面质量^[12]。分别用 5%、 10%、15% 质量分数的 HF 酸溶液对石英玻璃进行 15 min 的蚀刻,HF 酸处理后的石英玻璃在 355 nm 处透过率用分光光度计(日本岛津,型号: MPC -3100)测量。5%、10%、15% 质量分数的 HF 酸刻蚀 15 min 后的石英玻璃透过率和激光损伤阈值测量 结果如图 2 所示,质量分数浓度 0% 表示为 HF 酸未 刻蚀的石英玻璃。

从图 2 可以看出经 5%、10%、15% 质量分数的 HF 酸进行 15 min 刻蚀后石英玻璃的透过率和损伤 阈值均有明显提高,均随 HF 酸浓度的增加呈现先 增加后下降变化,分别在 HF 酸浓度 5% 和 10% 质 量分数时达到最大值。经 5%、10%、15% 质量分数 的 HF 酸处 理后 石英 玻璃 的损伤阈值分别为 6.12 J/cm²、10.34 J/cm²、9.18J/cm²,相对于未经酸 处理而言分别提高了 7.9%、82.4%、61.9%,实验 结果表明在 HF 酸浓度为 10% 时刻蚀 15 min 的 355 nm 激光损伤阈值提高最大。以 10% 质量分数 浓度的 HF 酸分别对 4 块石英玻璃样品蚀刻 10 min、30 min、60 min 和 120 min 后的透过率和激 光损伤阈值测量结果如图 3 所示,刻蚀时间为 0 表示为未经 HF 酸刻蚀的石英玻璃。

本文开展了基于 HF 酸刻蚀方法对石英玻璃 表面进行处理,提高了 355 nm 的激光诱导损伤阈 值,并且 355 nm 的光学透过率增加。石英玻璃的 透过率和损伤阈值在质量分数 5%、10%、15% 的 HF 浓度蚀刻石英玻璃 15 min 时均有提高,且在质 量分数 10% 的 HF 浓度 355 nm 激光损伤阈值提高 了 82.4%。在质量分数 10% 的 HF 浓度下刻蚀 10 min、30 min、60 min、120 min,发现蚀刻 60 min 后石英玻璃的激光损伤阈值提高 167.5%。在相 同激光能量密度作用下情况下,小能量密度时 HF 酸处理石英玻璃表面损伤损伤面积比无酸处理的 损伤形貌小,而大能量密度时 HF 酸处理石英玻璃 表面损伤损伤面积比无酸处理的损伤形貌大。HF 酸刻蚀石英玻璃,消除或钝化了样品在机械加工 过程中产生的微裂纹,去除了亚表面缺陷,从而提 高石英玻璃的激光诱导损伤阈值,因而 HF 酸化学 处理对提高石英玻璃抗激光损伤能力是相当有效 的。经 HF 酸处理后的石英玻璃表面出现了玻璃 加工痕迹,造成表面平滑度降低,需要二次加工才 能进行使用。

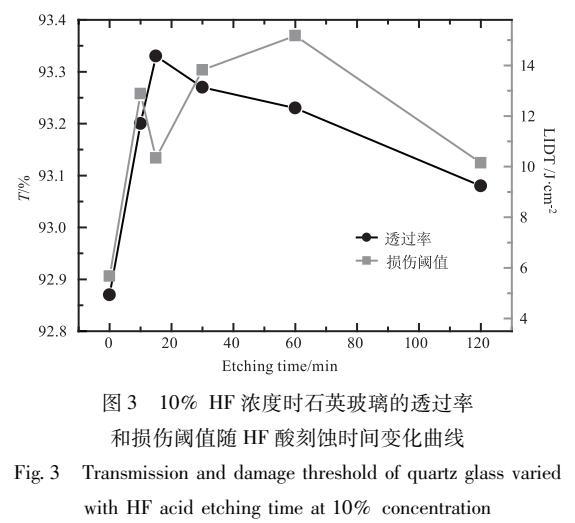
从图 3 可知在质量分数 10% 浓度的 HF 酸分别 对 5 块石英玻璃样品刻蚀 10 min、15 min、30 min、 60 min 和 120 min 后石英玻璃的透过率和损伤阈值 均有明显提高,整体上均随 HF 酸处理时间增加呈现 先增加后下降变化,分别在 HF 酸刻蚀时间 15 min 和 60 min 时达到最大值。经 HF 酸刻蚀时间 15 min 和 60 min 时达到最大值。经 HF 酸刻蚀 10 min、15 min、 30 min、60 min 和 120 min 后石英玻璃的 355 nm 激光 损 伤 阈 值 分 别 为 12.88 J/cm²、10.34 J/cm²、 13.82 J/cm²、15.17 J/cm²、10.15 J/cm²,相对于未经 酸处理而言分别提高了 127.2%、82.4%、143.7%、 167.5%、79.0%,实验结果表明在 HF 酸浓度为 10% 时刻蚀 60 min 的 355 nm 激光损伤阈值提高最大。

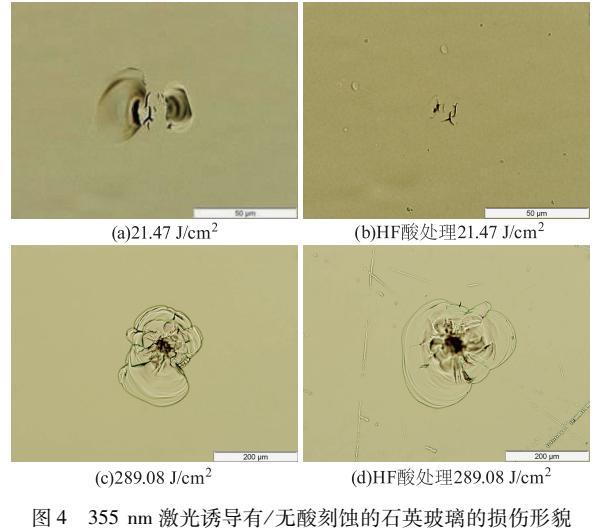
Fig. 4 quartz glass surface damage morphology induced by 355 nm pulse laser with/without HF acid etching

图 4 为相同能量密度 355 nm 激光诱导有/无酸 蚀刻的石英玻璃的损伤形貌。图4(a)和(c)是无 HF 酸处理石英玻璃表面损伤形貌,激光能量密度 分别为21.47 J/cm²和289.08 J/cm²,损伤面积分别 为 $2.3 \times 10^3 \mu m^2$ 和 $4.8 \times 10^4 \mu m^2$ 。图 4(b) 和 (d) 为 10% 质量分数浓度的 HF 酸刻蚀 60 min 后的石英玻 璃表面损伤形貌,激光能量密度分别为21.47 J/cm² 和 289.08 J/cm², 损伤面积分别为2.7 × 10^2 μ m²和 7.1×10⁴ μm²。对比 355 nm 激光诱导有/无酸刻蚀 的石英玻璃的损伤形貌可知,在小激光能量密度时, 经过 HF 酸处理过的石英玻璃激光损伤阈值提高, 与未处理的石英玻璃相比较而言损伤面积小,这是 因为 HF 酸处理后,石英玻璃表面杂质、污染物等减 少,从而对355 nm 激光脉冲吸收减弱,从而激光损 伤面积较小;当高激光能量密度时,经 HF 酸处理过 的石英玻璃激光损伤面积与未处理的石英玻璃相比 较而言损伤面积变大,这是由于激光损伤过程中产 生的冲击波横向传输未受到杂质缺陷等约束,冲击 力诱导产生表面损伤,从而使损伤面积变大,另外对 比还可发现 HF 酸处理后的样品表面炸裂现象 减弱。

石英玻璃的 355 nm 激光诱导损伤是由多光子 吸收导致的雪崩电离机制造成,损伤过程中冲击波 作用下产生拉应力和压应力超过石英玻璃本身的抗 拉和抗压强度产生裂纹出现,由于玻璃介质的非线 性效应出现小尺寸自聚焦效应,石英玻璃的激光毁 伤表现为以炸裂形式破坏。石英玻璃表面切割、研 磨、抛光工艺过程中,在亚表面及表面产生微裂纹、 划痕等,石英玻璃表面附着抛光粉一层重沉积层,这 些缺陷形成入射 355 nm 激光的光吸收中心,导致石 英玻璃的激光损伤阈值较本征石英玻璃降低。HF 酸刻蚀石英玻璃,有效去除了表面的重沉积层,消除 或钝化了样品在机械加工过程中产生的微裂纹^[13], 去除了亚表面缺陷,从而提高石英玻璃的激光诱导 损伤阈值^[14],因而 HF 酸化学处理对提高石英玻璃 抗激光损伤是相当有效的。
